Triggered Surface Slips in Southern California Associated with the 2010 El Mayor-Cucapah, Baja California, Mexico, Earthquake

Open-File Report 2010-1333

Jointly published as California Geological Survey Special Report 221

By Michael J. Rymer, Jerome A. Treiman, Katherine J. Kendrick, James J. Lienkaemper, Ray J. Weldon, Roger Bilham, Meng Wei, Eric J. Fielding, Janis L. Hernandez, Brian P. E. Olson, Pamela J. Irvine, Nichole Knepprath, Robert R. Sickler, Xiaopeng Tong, and Martin E. Siem

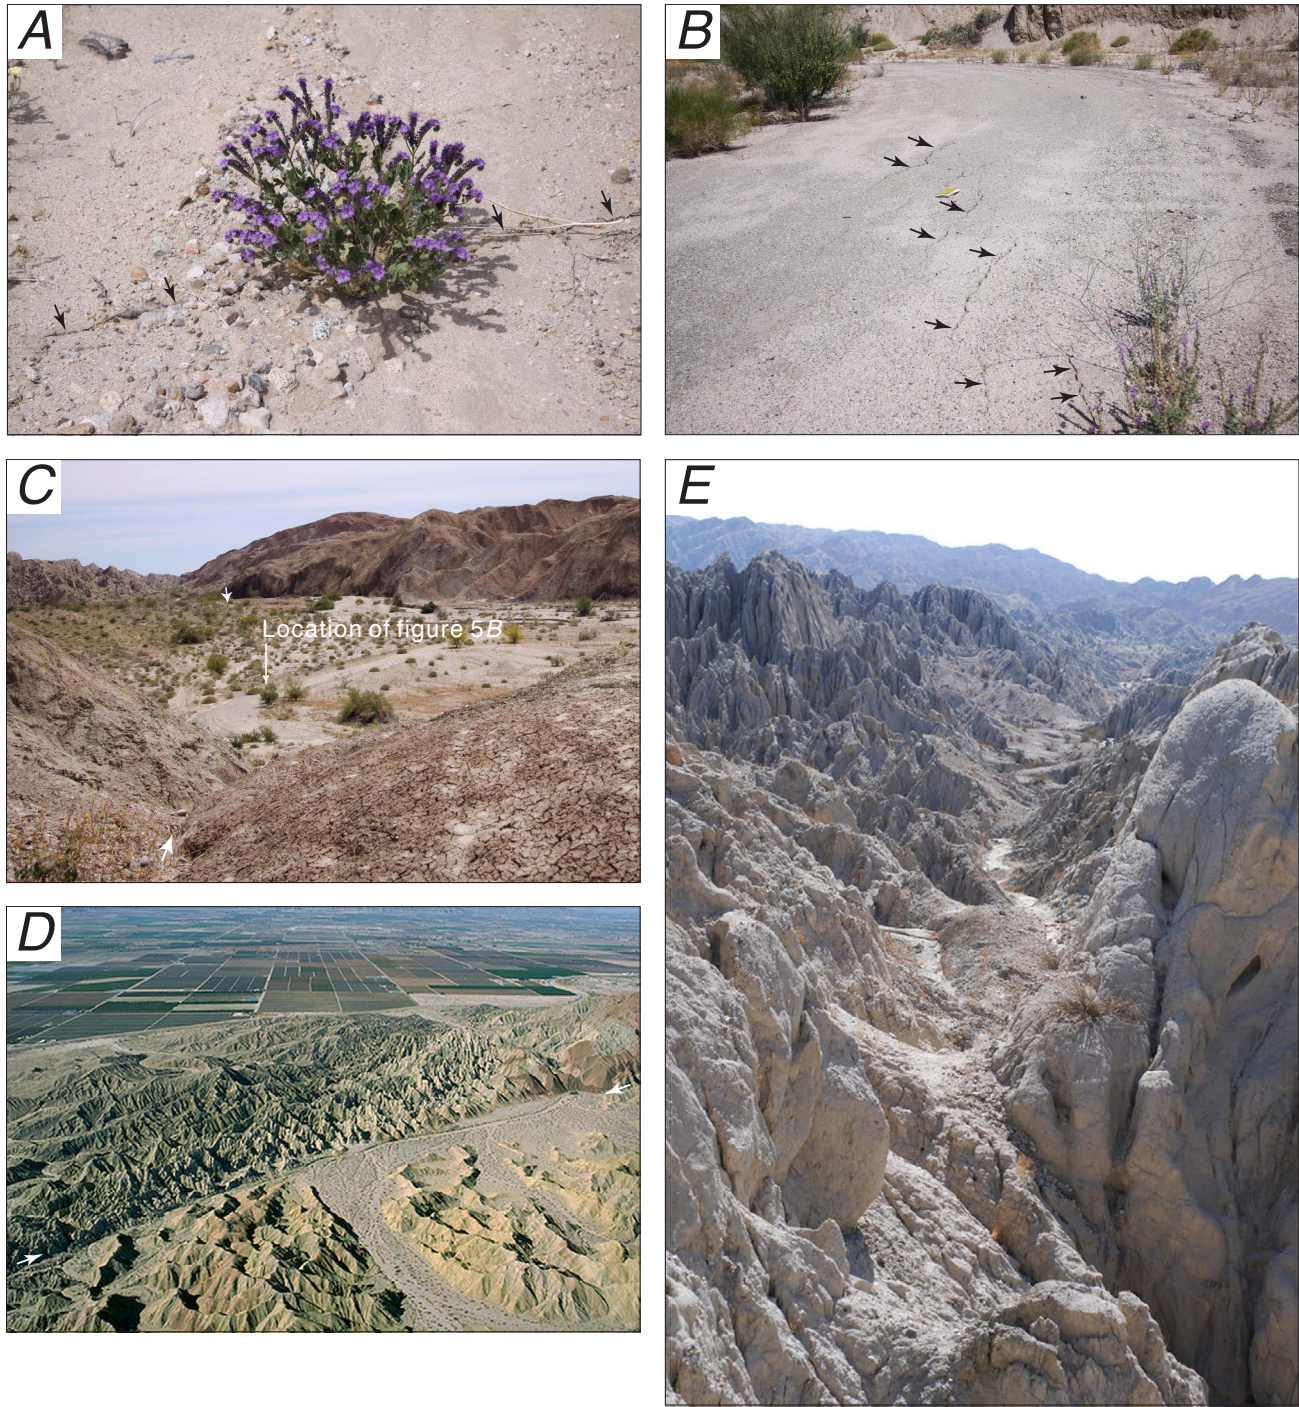
Figure 5. Photographs of fractures formed in response to the El Mayor-Cucapah earthquake and views of the San Andreas Fault in southeastern Coachella Valley. *A*, Fractures (black arrows) along San Andreas Fault in active wash between Thermal Canyon and Quarry Canyon; view to the northeast (see fig. 4, panel A–B for location). Photograph taken April 20, 2010, by K.J. Kendrick. *B*, Left-stepping fractures (black arrows) along San Andreas Fault in gravel road in Quarry Canyon. Photograph taken April 20, 2010, by K.J. Kendrick; view to the northwest. Green notebook in center of view for scale. *C*, View along San Andreas Fault (between white arrows) in Quarry Canyon; view to the southeast. Photograph taken April 20, 2010, by K.J. Kendrick. *D*, Oblique aerial view of San Andreas Fault (between white arrows) near Red Canyon; view to the west. Location of image shown in figure 4, panel B–C. Dark reddish-brown deposit beyond right white arrow is a sandy mudstone that was tectonically emplaced along this section of the San Andreas Fault. *E*, View along San Andreas Fault between Red Canyon and Painted Canyon; view to the southeast.

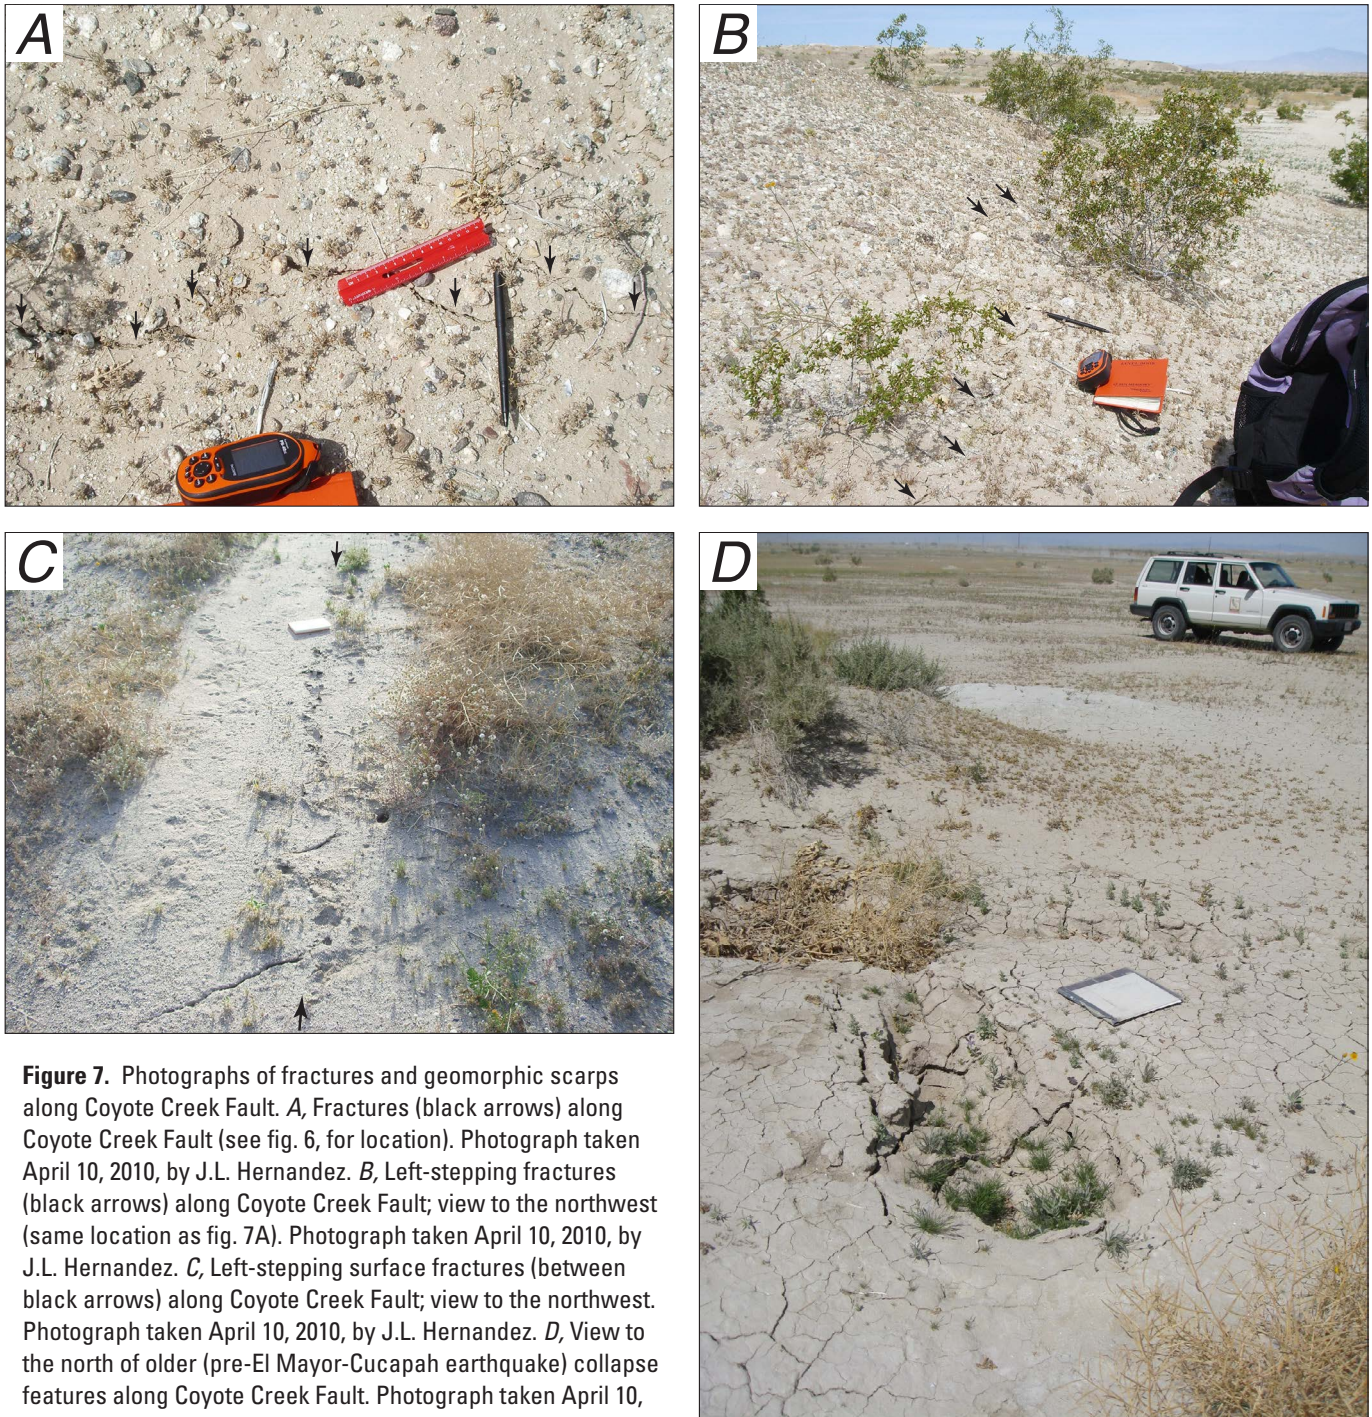
Figure 7. Photographs of fractures and geomorphic scarps along Coyote Creek Fault. *A*, Fractures (black arrows) along Coyote Creek Fault (see fig. 6, for location). Photograph taken April 10, 2010, by J.L. Hernandez. *B*, Left-stepping fractures (black arrows) along Coyote Creek Fault; view to the northwest (same location as fig. 7A). Photograph taken April 10, 2010, by J.L. Hernandez. *C*, Left-stepping surface fractures (between black arrows) along Coyote Creek Fault; view to the northwest. Photograph taken April 10, 2010, by J.L. Hernandez. *D*, View to the north of older (pre-El Mayor-Cucapah earthquake) collapse features along Coyote Creek Fault. Photograph taken April 10, 2010, by J.A. Treiman.

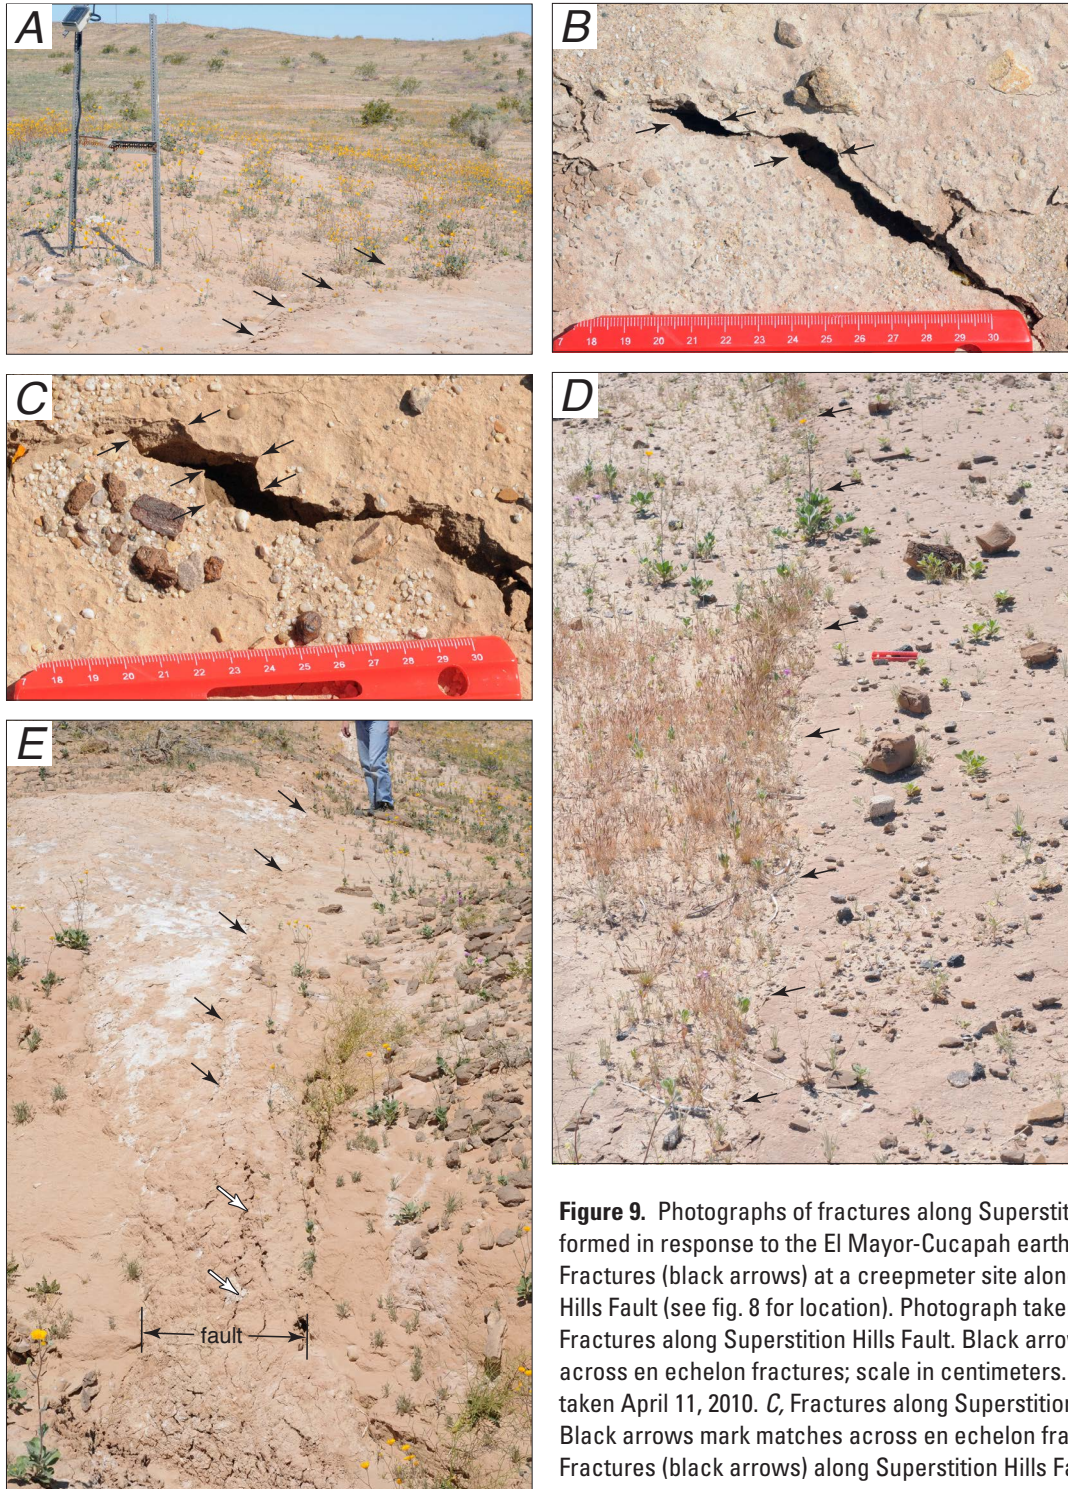
Observed offset was small, less than 16 mm (figs. 8, 9A–C). The amount of dextral slip was largest near the southeastern end of the central or Imler strand (fig. 8). Locally, a small vertical component of slip was measured; nowhere did

One of the most remarkable similarities between prior triggered slip events and the 2010 event is in the reoccupation of surface breakage localities. In each event, surface deformation recurred within a few centimeters of previous locations. Nail arrays and wooden-peg arrays placed across the Superstition Hills Fault following the 1987 primary surface faulting were offset by the El Mayor-Cucapah earthquake in exactly the same place as in 1987 and in intervening afterslip and triggered slip events. Figure 9D shows a site where slip was observed in 2010 and previous triggered slip events, all of which are superimposed on a preexisting fault scarp. At this location, the Superstition Hills Fault has juxtaposed different lithologies (siltstone against sandstone) that produce a pronounced vegetation lineament. Local, deep stream-cut exposures that cross the Superstition Hills Fault document the persistence of surface slip locations (fig. 9E).

Figure 9. Photographs of fractures along Superstition Hills Fault formed in response to the El Mayor-Cucapah earthquake. *A*, Fractures (black arrows) at a creepmeter site along Superstition Hills Fault (see fig. 8 for location). Photograph taken April 8, 2010. *B*, Fractures along Superstition Hills Fault. Black arrows mark matches across en echelon fractures; scale in centimeters. Photograph taken April 11, 2010. *C*, Fractures along Superstition Hills Fault. Black arrows mark matches across en echelon fractures. *D*, Fractures (black arrows) along Superstition Hills Fault; view to the southeast. The fault has juxtaposed relatively clay-rich and sand-rich strata from the same mid-Pleistocene sedimentary sequence, the transition expressed as a vegetation lineament. Photograph taken April 8, 2010. *E*, Fractures (black arrows) along Superstition Hills Fault where ground surface is cut by a gulley. Fractures (white arrows) continue into near-vertical gulley exposure, where Quaternary fault (see label) is visible; view to the northwest. Photograph taken April 8, 2010.

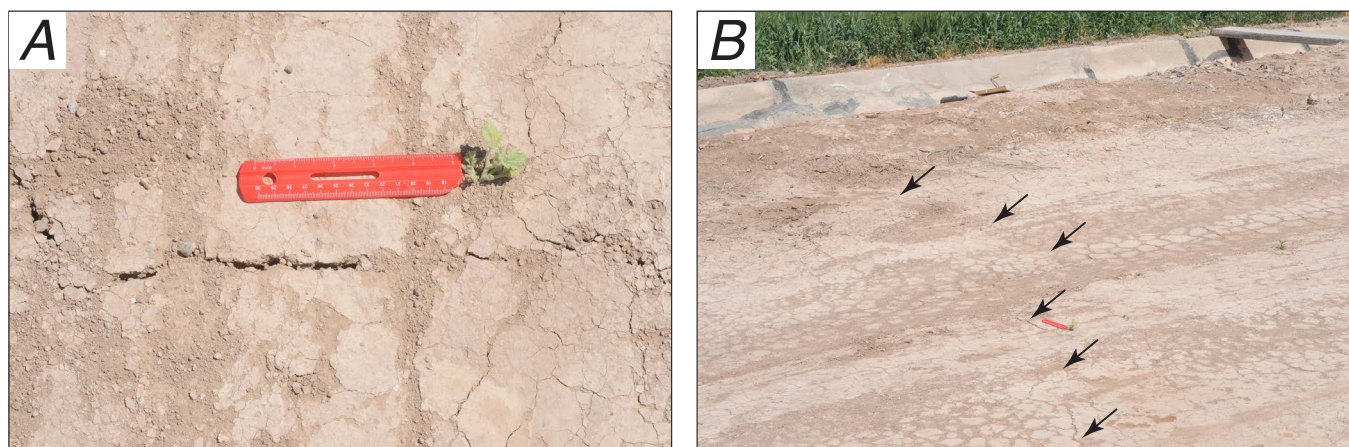
where the fault had broken the surface during a swarm of microearthquakes in 2005 (Lohman and McGuire, 2007; Rymer, Hudnut, and Kendrick, unpublished work). The 2005 slip event resulted in a series of fault breaks about 170 m long that vertically offset a concrete-lined canal. Slip on the Kalin Fault manifests as nearly pure vertical slip. In 2005 the ground surface was freshly warped, if not also faulted, for a distance extending north-northeastward from the offset canal liner at least 800 m into an adjacent field of dense crops (figs. 11, 12*B*).

Figure 12. Photographs of Kalin Fault and surface fractures formed in response to the 2010 El Mayor-Cucapah earthquake. *A*, Vertical view of fractures with 14-cm-long scale. *B*, View of fractures across dirt roadway. Concrete canal liner (at top of photo) was not broken by new fractures. Photographs taken April 10, 2010.

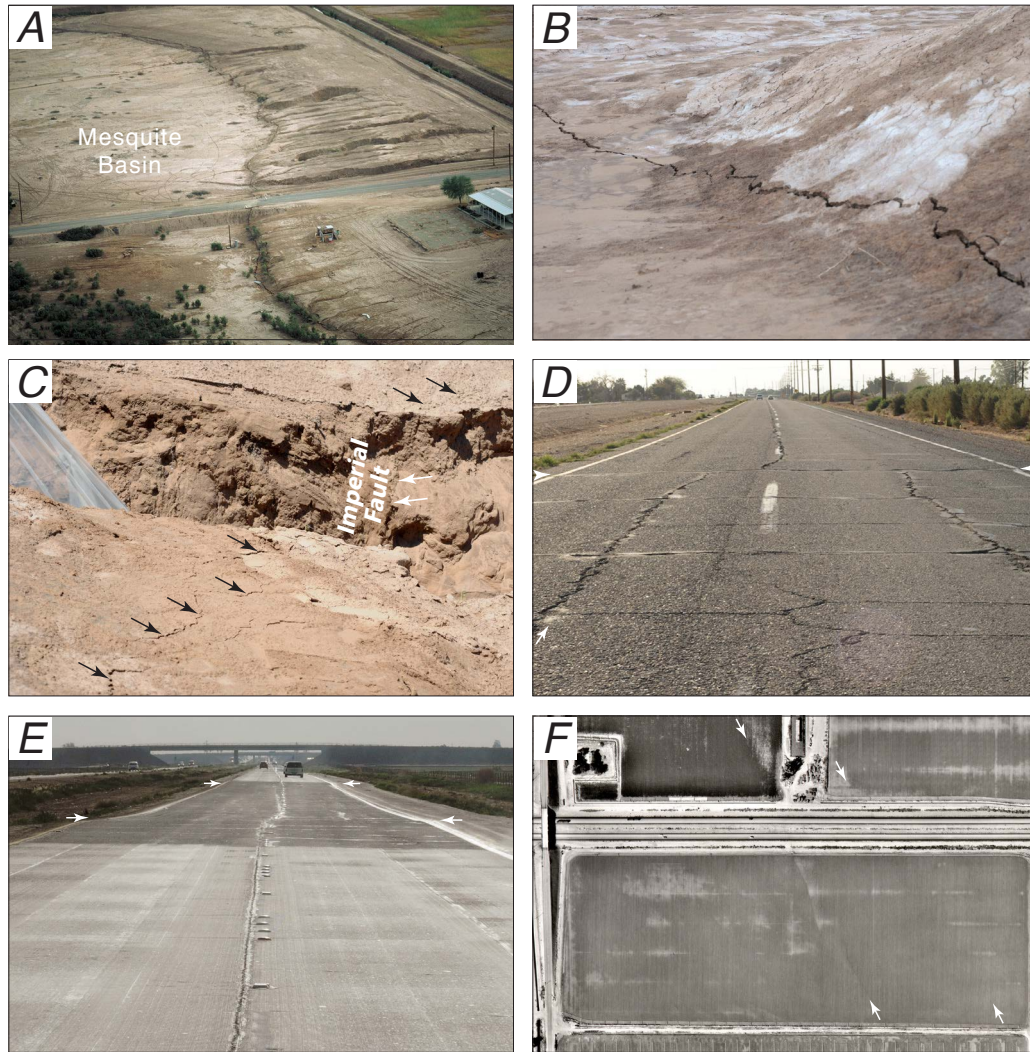
A. Meltzner, and T. Rockwell) align with the fault plane in the near surface at this location along the Imperial Fault (fig. 14C). Figure 14D shows surface expression and evidence of tectonic offset from the 1940 and 1979 earthquakes and their respective afterslips. This 2009 view to the west along Evan Hewes Highway shows the cumulative slip where the fault crosses the pavement. Unfortunately for geologic investigations, this roadway was repaved in the months before the 2010 El Mayor-Cucapah earthquake. The photograph was taken in March 2009, and a subsequent visit to the site revealed the same scene in June 2009. Movement on the Imperial Fault (identified by white arrows on the sides of the photo) has offset the center paving joint (center of road on distant side of fault and white arrow in bottom-left of image). We did not observe fresh surface fractures at this location following the El Mayor-Cucapah earthquake. This is consistent with other, nearby observations of no new slip. However, Interstate 8 was offset in 2010 (fig. 14E, F). We measured surface fractures on the northern frontage road of I-8 (to the left in fig. 14E; fig. 13, panel Y–Z). Figure 14F shows approximately the same area as figure 14E but is a vertical aerial view taken immediately after the 1979 Imperial Valley

Figure 14. Photographs of surface fractures and long-term offset of features along the Imperial Fault. *A*, Aerial photograph of the Imperial Fault at Harris Road. Photograph taken October 1979, shortly after the 1979 Imperial Valley earthquake. View to the southwest. *B*, Locally continuous, right-oblique surface fractures along Imperial Fault; view to the southwest. Photograph taken about 70 m south of Harris Road; photograph shows about 4 meters of surface fractures. Photograph taken April 5, 2010. *C*, Right-lateral surface fractures along Imperial Fault across and through a paleoseismic trench exposure. Photograph shows surface fractures (black arrows) and fresh fractures in a vertical exposure in the trench wall (white arrows), along edge of long-term Imperial Fault; view to the south. Photograph taken April 11, 2010. *D*, Right-lateral fault offset at Evan Hewes Highway due to recurrent movement on the Imperial Fault. View to the west. Photograph taken March 12, 2009; roadway was resurfaced some time between June 2009 and April 2010. *E*, Right-lateral fault offset at I-8 due to recurrent movement on the Imperial Fault; view to the east. Photograph taken April 11, 2010. *F*, Vertical aerial photograph of the Imperial Fault and I-8, showing two fault traces (between white arrows) in a structural stepover (compare with fault map in fig. 13). North is at top in this view. Photograph taken October 16, 1979.

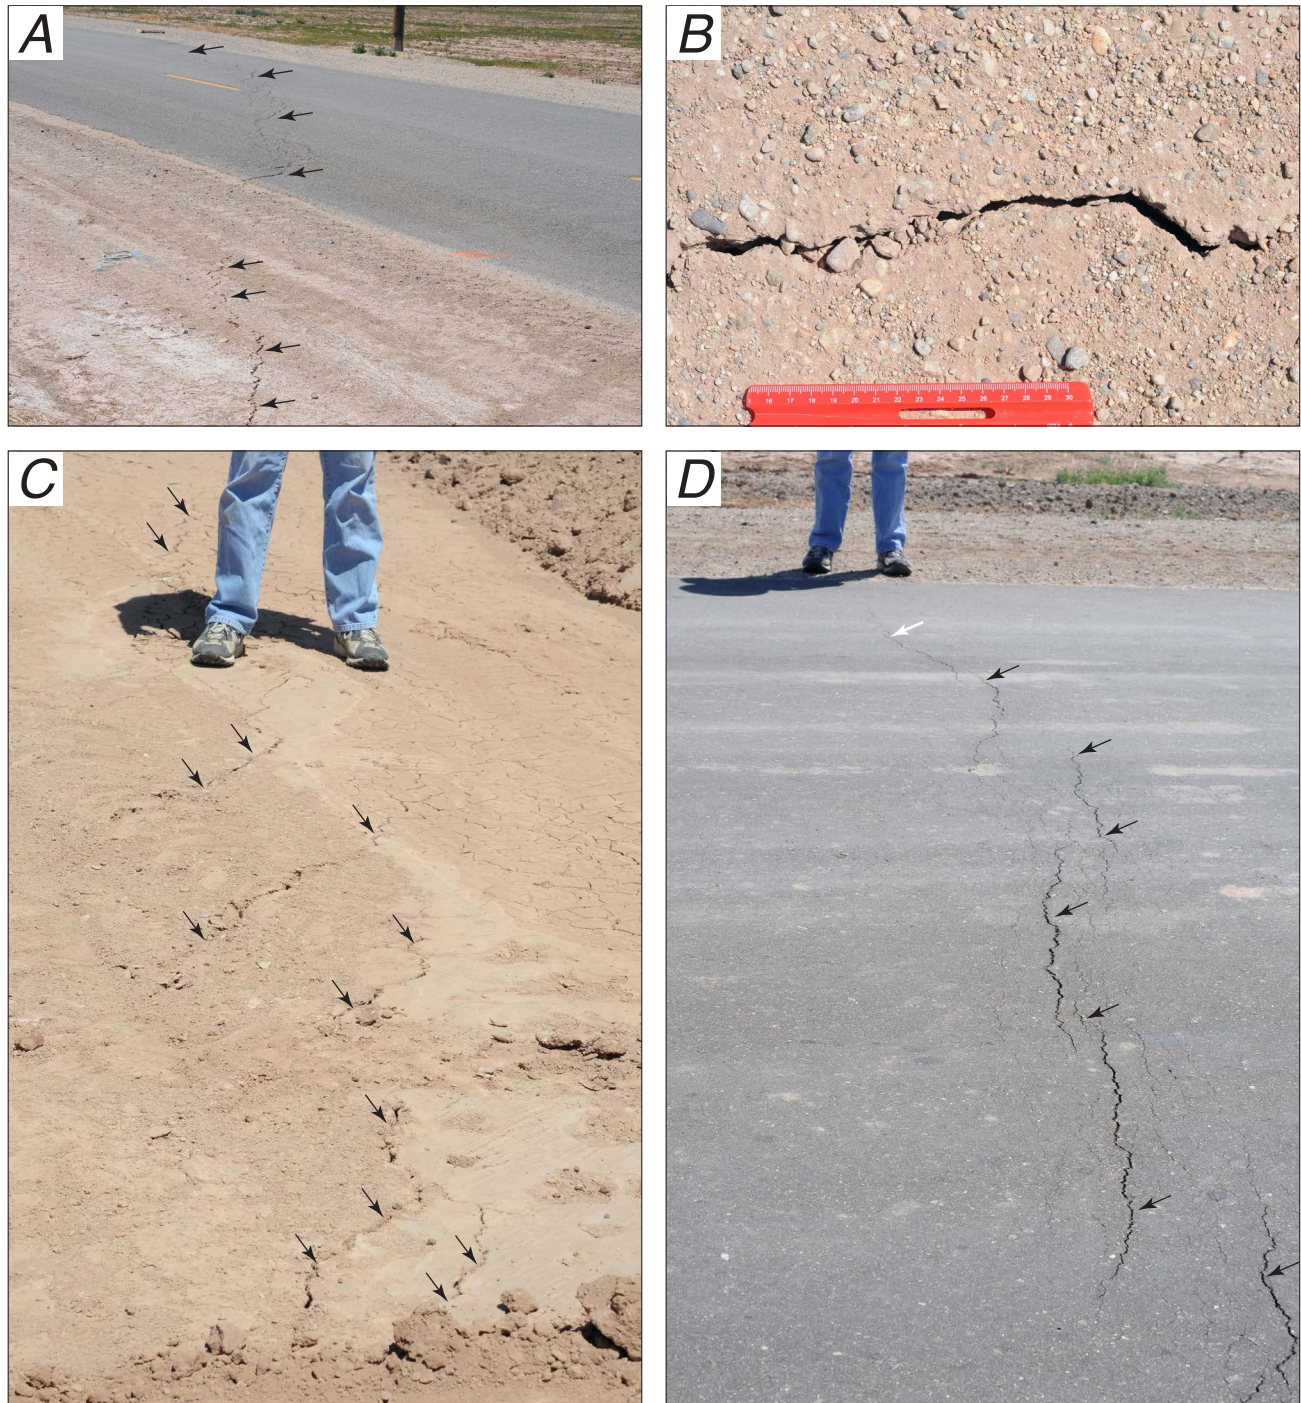
Figure 16. Photographs of surface fractures along Brawley Fault Zone in response to the 2010 El Mayor-Cucapah earthquake. *A*, Surface fractures (black arrows) along Brawley Fault Zone and across McConnell Road; view to the southwest. Photograph taken April 9, 2010. *B*, Close-up view of fresh surface fractures along Brawley Fault Zone in shoulder of Harris Road; scale in centimeters. Photograph taken April 9, 2010. *C*, Left-stepping, fractures (black arrows) along Brawley Fault Zone and across shoulder of Harris Road; view to the north. Photograph taken April 9, 2010. *D*, Fresh surface fractures (black arrows) along Brawley Fault Zone and across Ralph Road; view to the north. Slight vertical component of slip (2 mm, up on east [right] side) more noticeable at white arrow. Photograph taken April 9, 2010.

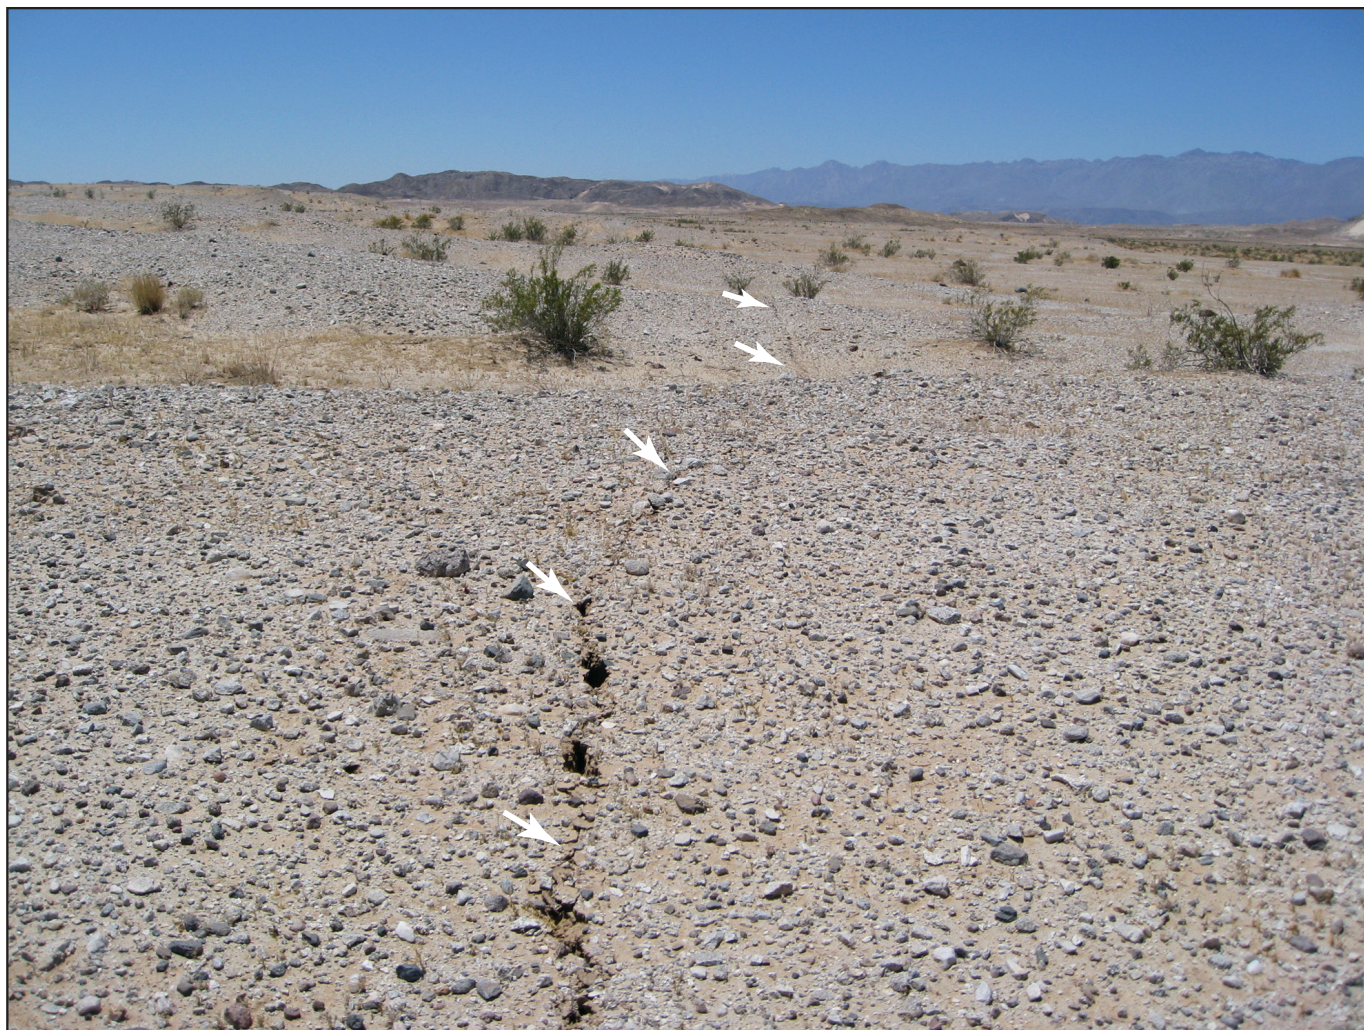
Figure 20. Photograph of surface fractures along fault south of Pinto Wash; view to the northeast. See figure 19 for location. Photograph taken June 18, 2010, by J.A. Treiman.

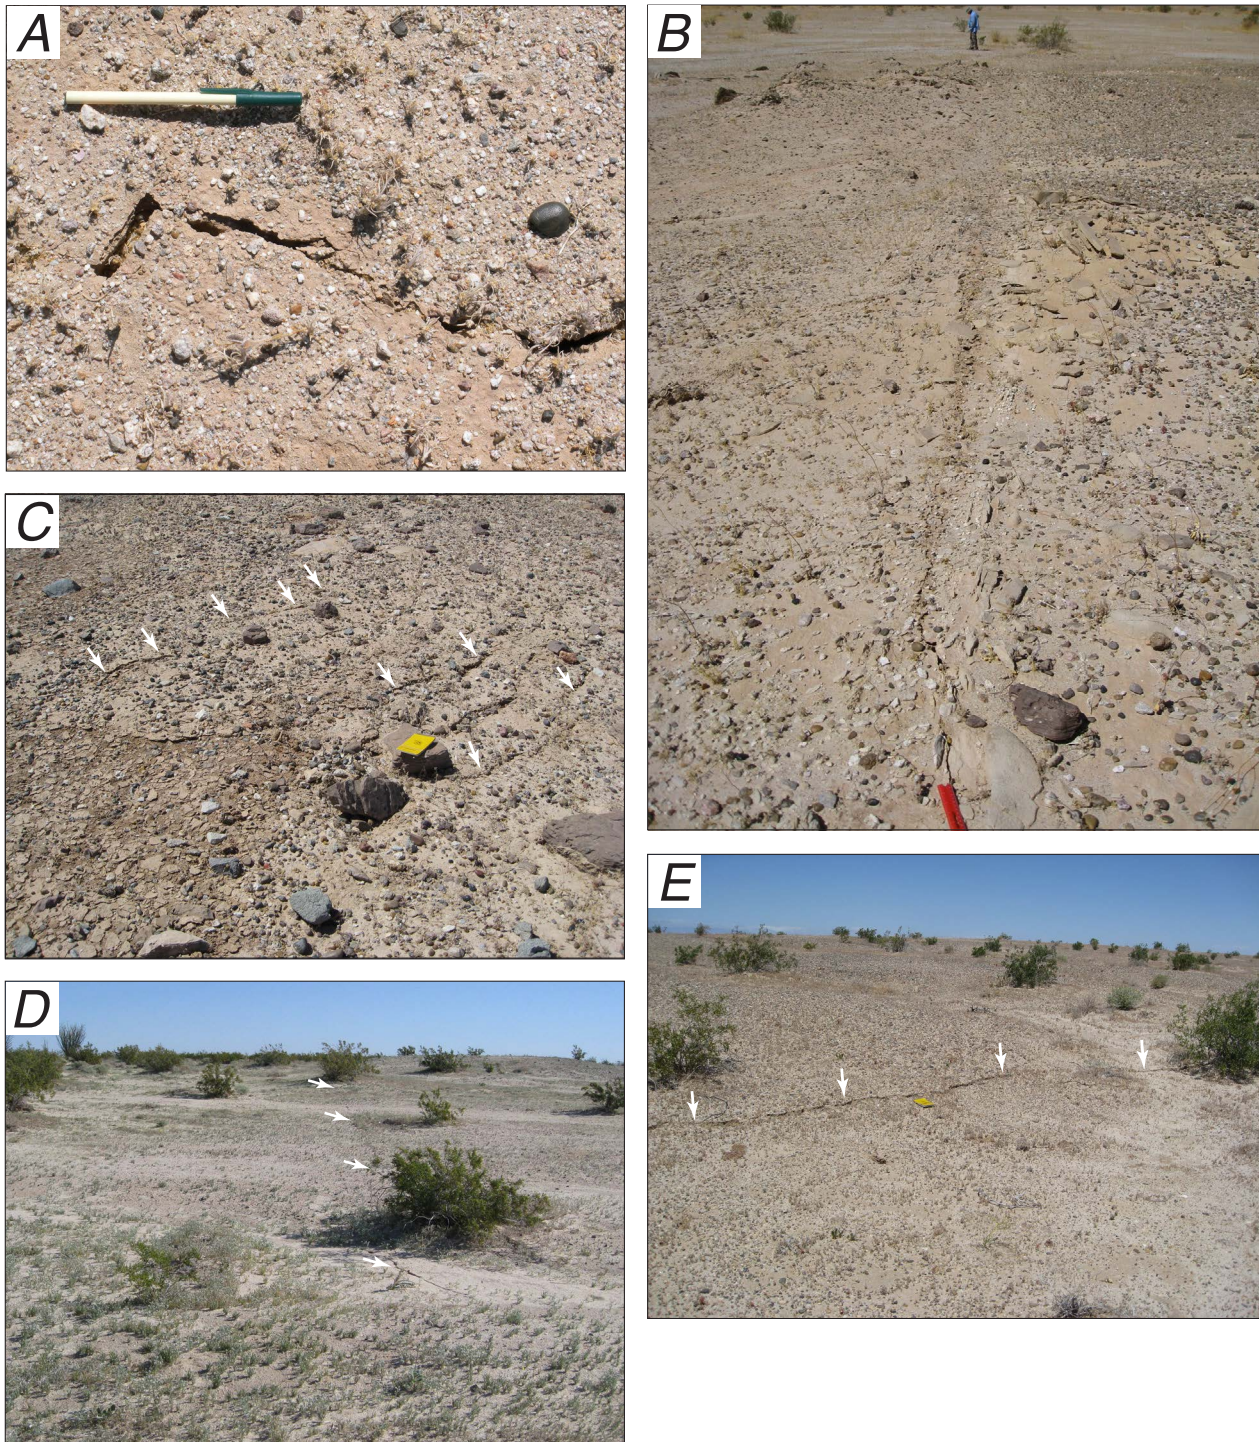
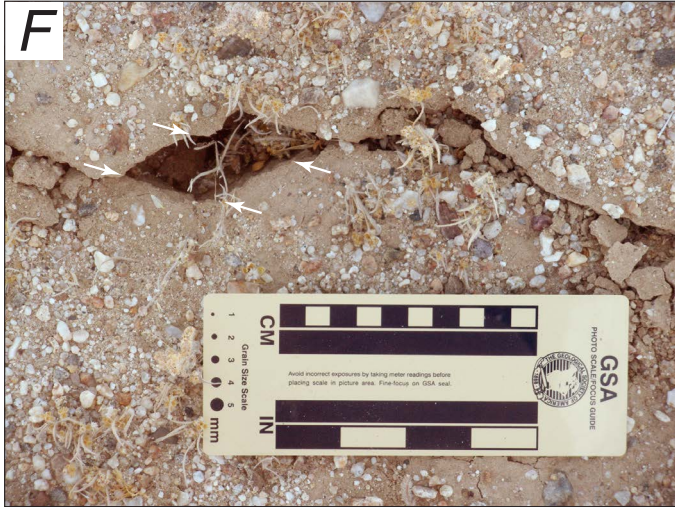
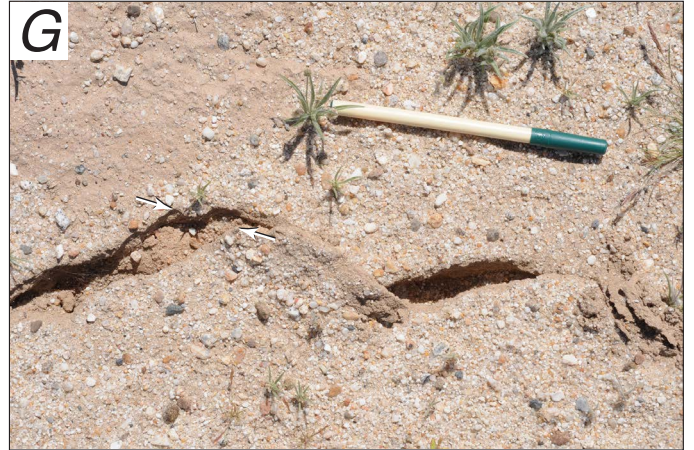
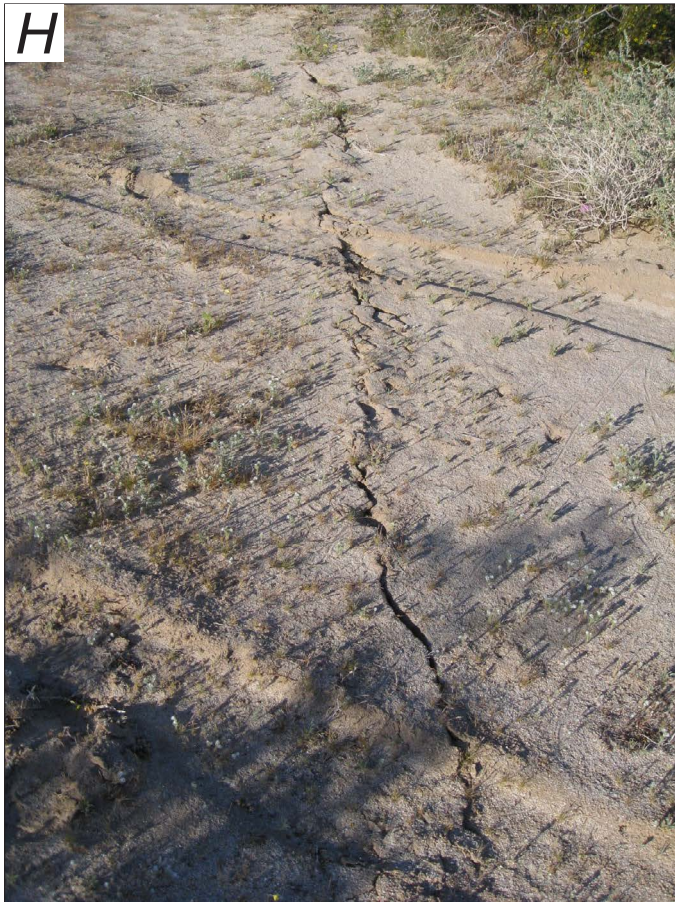
Figure 22. Photographs of fractures and Quaternary fault scarps along faults shown in figure 21. *A*, Left-lateral fractures along unnamed fault south of Pinto Wash, pen for scale. Photograph taken June 18, 2010. *B*, Continuous left-lateral fractures along unnamed fault south of Pinto Wash (surface slip extends between red scale in foreground and geologist in distance); view to the southwest. This section of fault consists of a cemented shear zone. Photograph taken June 18, 2010, by J.A. Treiman. *C*, Shattered and overturned surface crust. Shattered ground may be partly a topographic effect, given that the site is on a low ridge adjacent to a fault (as indicated by UAVSAR interferogram), which had no new surface fault breakage. There may also be some lateral spread of the ridge toward a wash

immediately to the southeast (note fractures marked with white arrows). Photograph taken June 19, 2010, by J.A. Treiman. *D*, Fault scarp (at change in slope) with fractures (white arrows) along Yuha Fault; view to the northeast. Photograph taken April 7, 2010, by J.A. Treiman. *E*, Fault scarp (above change in slope) with fractures (white arrows) along Yuha Fault; view to the northwest. Yellow notebook (in center) for scale. Photograph taken May 11, 2010, by J.A. Treiman. *F*, Left-lateral fractures along Yuha Fault. White arrows mark matches across en echelon fractures. Photograph taken May 27, 2010. *G*, Left-lateral fractures along Yuha Fault. White arrows mark matching features across en echelon fracture; pen (15 cm long) for scale. Photograph taken April 7, 2010. *H*, Continuous left-lateral surface fractures along Yuha Fault, immediately south of State Highway 98; view to the northeast. Photograph taken April 6, 2010, by J.A. Treiman.

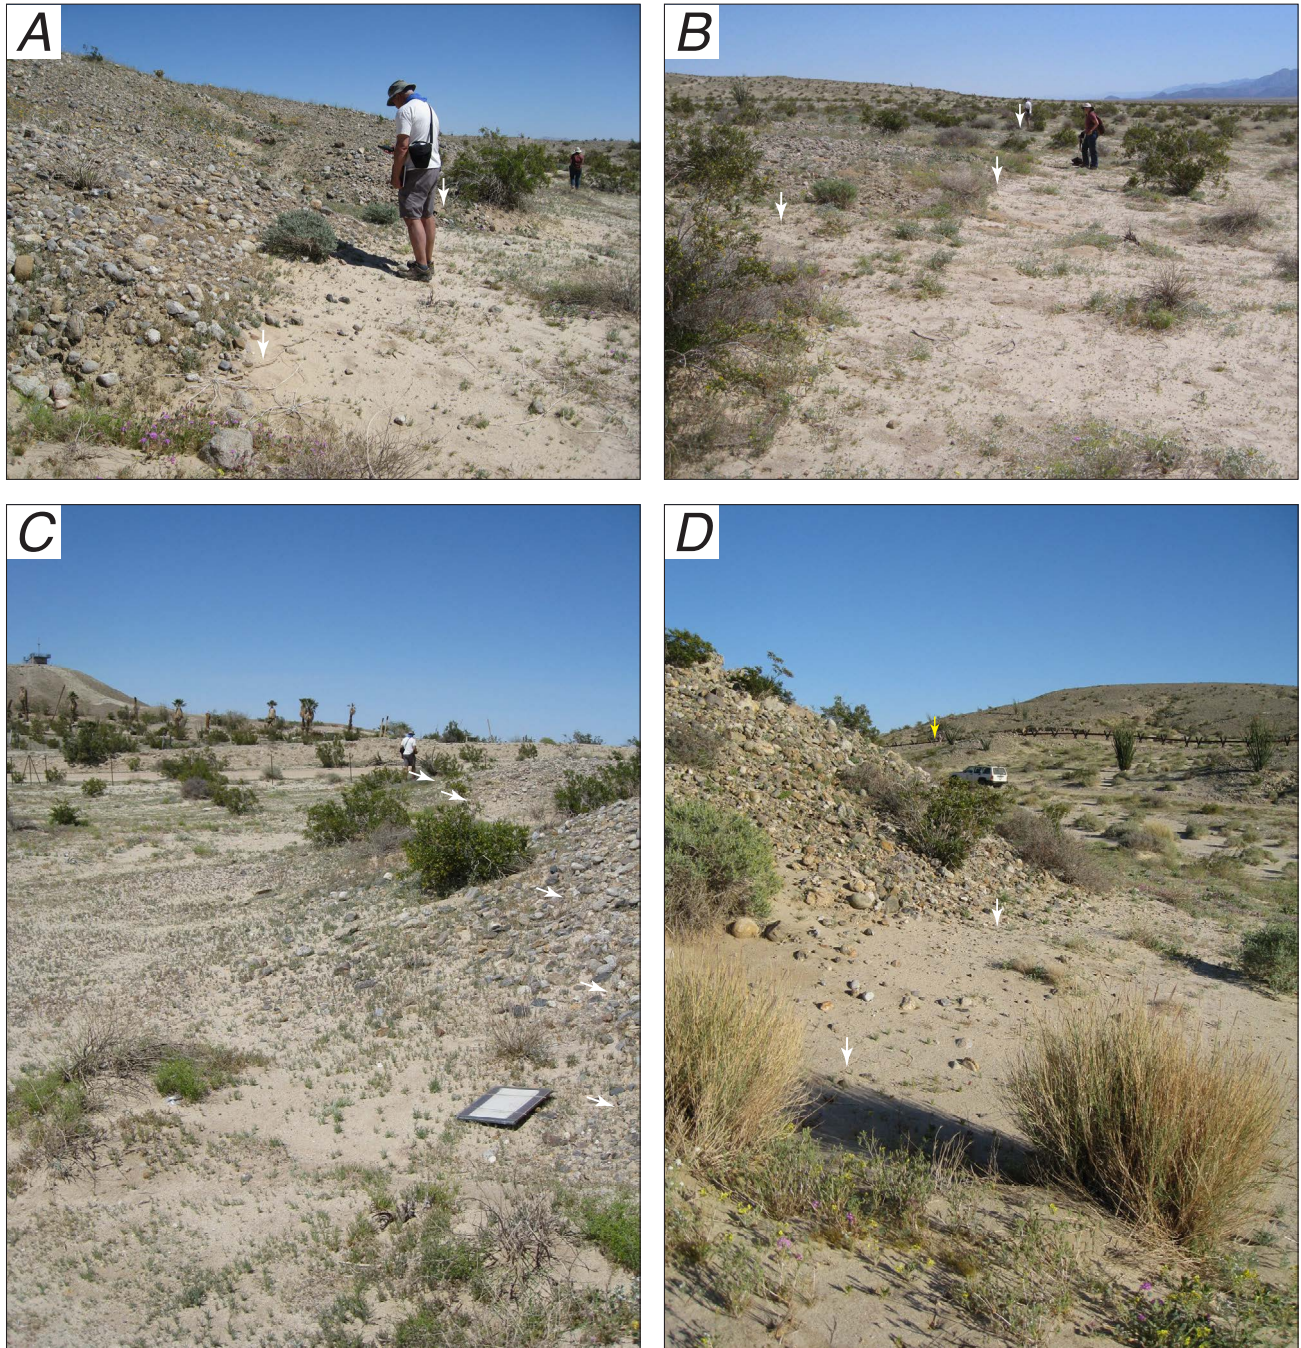
Figure 24. Photographs of fractures and fault scarps along faults shown in figure 23. *A*, Fault scarp (at change in slope) with fractures (white arrows) along the east branch of the Laguna Salada Fault; view to the south. Photograph taken April 6, 2010, by J.A. Treiman. *B*, Fault scarp (at change in slope) with fractures (white arrows) along east branch of the Laguna Salada Fault; view to the south. Photograph taken April 6, 2010, by J. A. Treiman. *C*, Fault scarp (at change in slope) with fractures (white arrows) along east branch of the Laguna Salada Fault; view to the north. Photograph taken April 6, 2010, by J.A. Treiman. *D*, Fault scarp (at change in slope) with fractures (white arrows) along east branch of the Laguna Salada Fault; view to the south. Location of U.S.-Mexico border fence marked with yellow arrow. Photograph taken April 8, 2010, by J.A. Treiman.

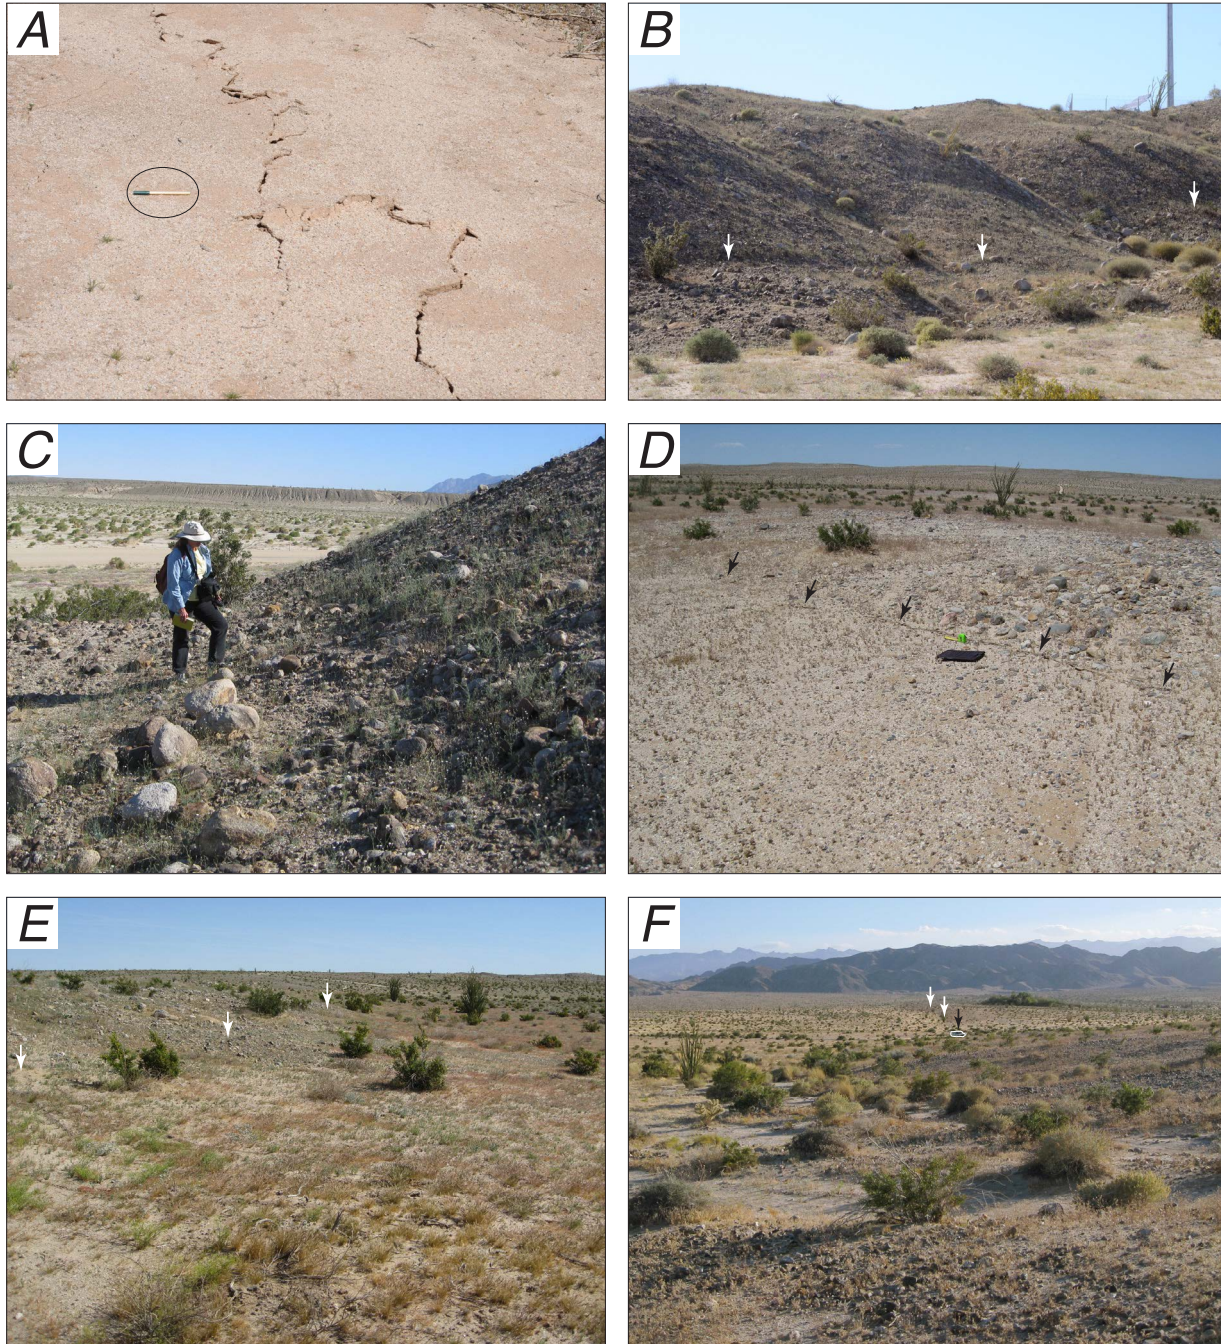
Figure 26. Photographs of fractures and fault scarps along faults shown in figure 25. *A*, Left-stepping, semicontinuous fractures with right-lateral offset and local “tent” structures along the Laguna Salada Fault, west branch; view to the northwest. Pen (circled) for scale. Photograph taken April 6, 2010. *B*, Fault scarp (white arrows) along Laguna Salada Fault, west branch. View to the west. Photo C is at leftmost arrow. Photograph taken April 7, 2010, by J.A. Treiman. *C*, Fault scarp (at change in slope, about 1 m in front of person) along Laguna Salada Fault, west branch; view to the south. Photograph taken April 7, 2010, by J.A. Treiman. *D*, Fault scarp (at change in slope) with fractures (black arrows) along one of several normal faults within an extensional zone near the juncture between the Laguna Salada Fault Zone and the Yuha Well Fault Zone; view to the north. Photograph taken May 12, 2010, by J.A. Treiman. *E*, Fault scarp (white arrows) along a northeast-trending fault within the Yuha Well Fault Zone; view to the northeast. Photograph taken April 6, 2010, by J.A. Treiman. *F*, Fault scarp (white arrows) along a fault within the Yuha Well Fault Zone; view to the southwest. Black arrow (and white outline), vehicle for scale. Photograph taken May 11, 2010, by J.A. Treiman.

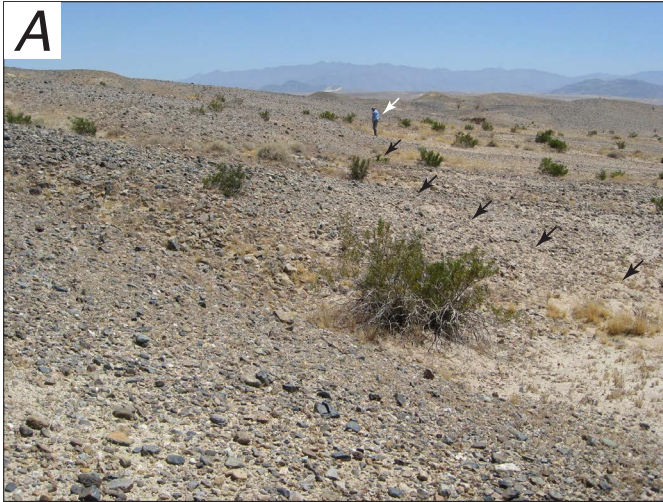
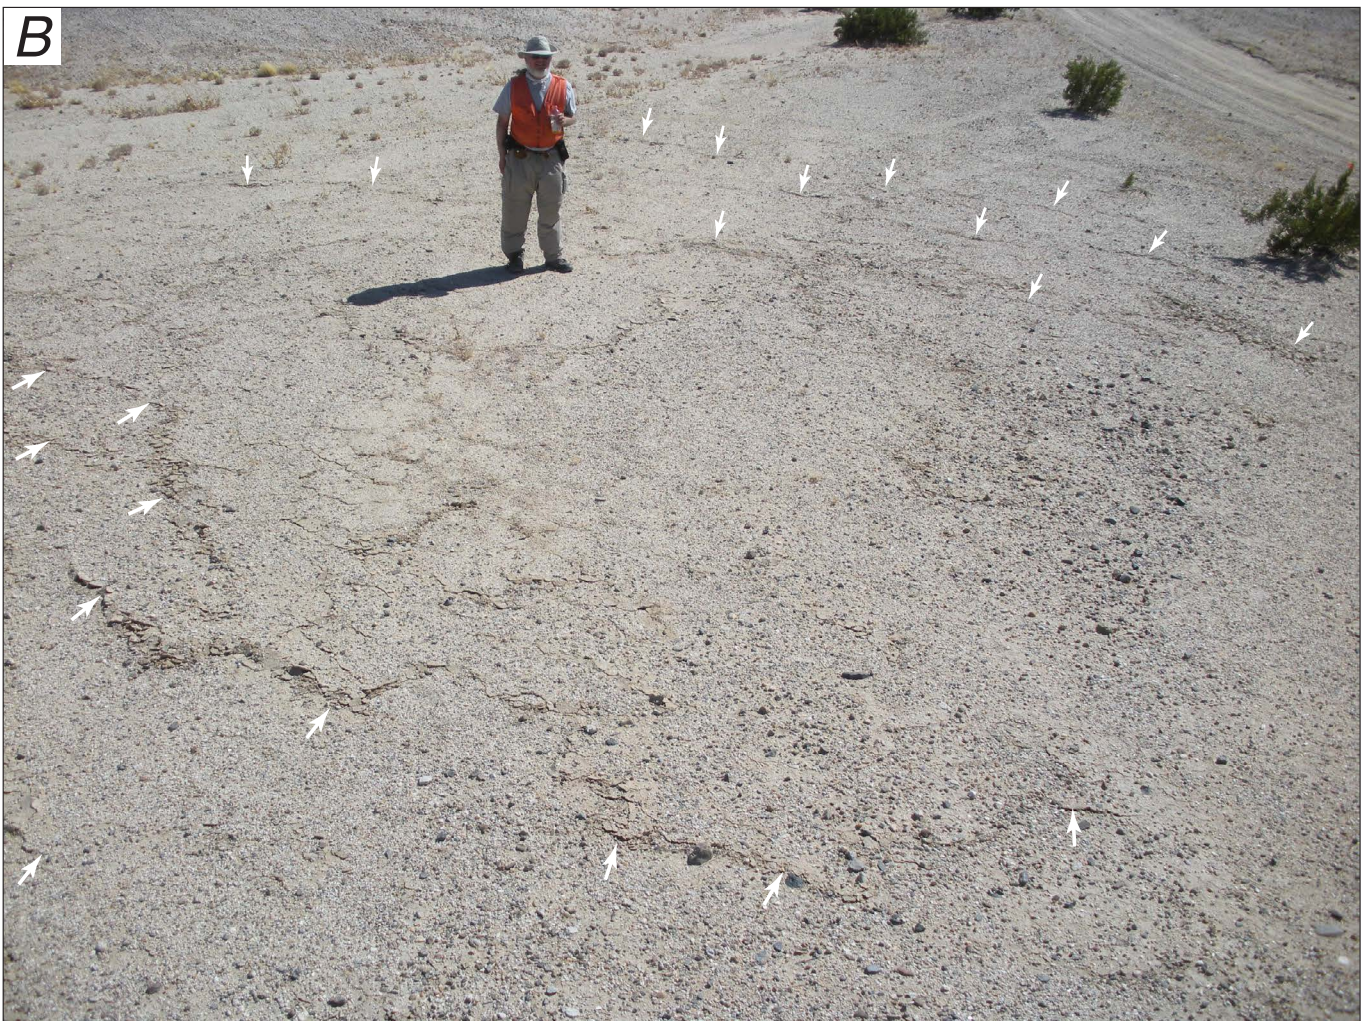
Figure 28. Faulting and nonfaulting fractures along the Yuha Well Fault. *A*, Discontinuous fractures (black arrows) along a dissected scarp in the northeastern section of the Yuha Well Fault; view to the southwest. Person for scale (white arrow). Photo taken June 18, 2010, by J.A. Treiman. *B*, Pole aerial photograph of fractures unrelated to surface faulting; view to the southeast. This is an example of nonfaulting, earthquake-related features; here fracturing in concentric rings (white arrows) centered in recent alluvial fill. Youngest material at site appears to have been “tossed” by recent earthquake activity, possibly by the June 14, 2010, M_w 5.7 aftershock (see text). Location of site shown in figure 27. Photo taken June 18, 2010.
